HOUSE DAMAGE ASSESSMENT

URS Research Company

Defense Nuclear Agency

June 1972

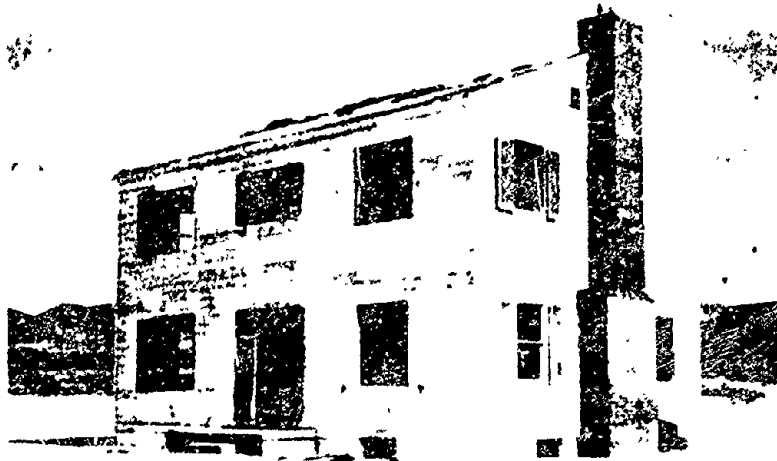
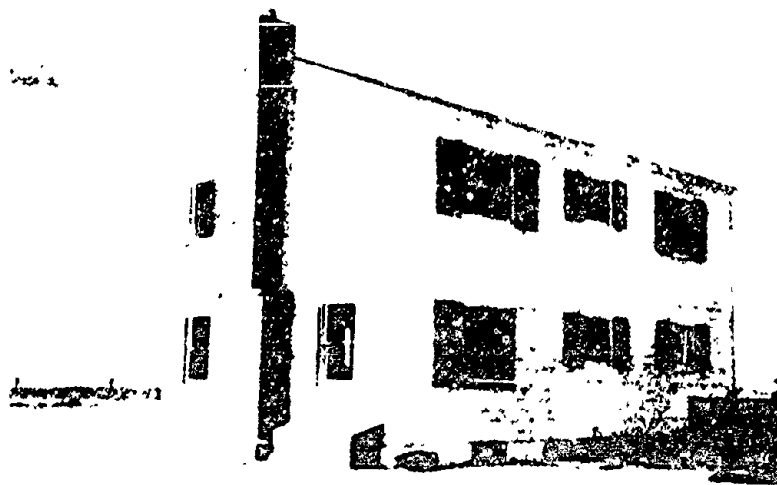
Fig. 2-1. Post-Test Photos, House I-1

This house was located at 7500 ft from ground zero where the incident peak overpressure was 1.7 psi. Post-test photographs of the exterior of the house are presented in Fig. 2-4. Doors, windows, and window frames were either blasted out of the walls or remained in place in a badly damaged condition. In general, the window glass was shattered into small particles and scattered uniformly about the exterior of the house. The only windows

remaining intact were four windows at the rear of the house which were sheltered by interior partitions, and the rear basement windows, which were blown open inwardly. The majority of the 2- by 8-in. floor joists of the front floor system were undamaged. Exceptions were a broken joist under the kitchen, three broken joists under the dining room, and the damage under the living room as shown in Fig. 2-5.

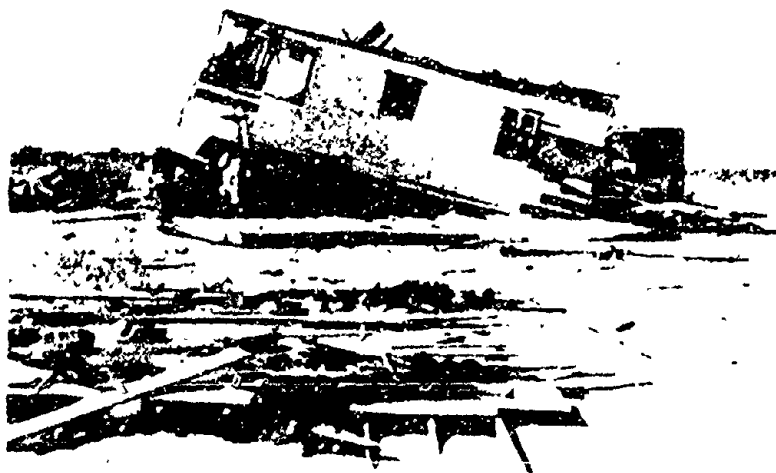
Fig. 2-14. Rear of House I-2

at the rear of the house. The ends of the wood girders at the front of the house moved off their bearings a maximum distance of 15 in. and the girders cantilevered from the front pair of pipe columns. Base and cap plates of the pipe columns leaned to the rear but did not overturn.

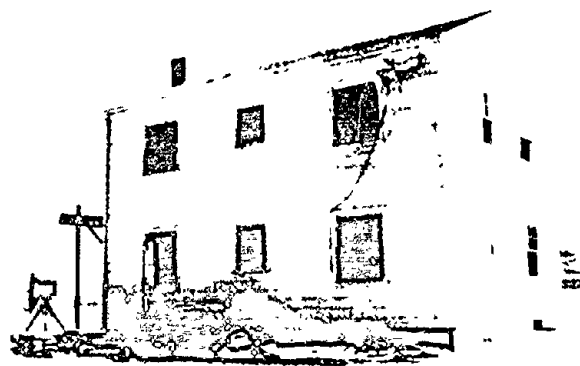
Fig. 2-28. Back and Left Side of House I-5

This house was located 865 ft from ground zero where the incident peak overpressure was 1.3 psi. After the blast, all the front windows except the small one above the front door were completely removed (see Fig. 2-27). Figure 2-28 is a view of the back and left side of the house. Note the window damage on the left wall, and the fact that only one pane of glass on the back wall was broken. Moderate chimney damage is indicated by the chalk marks in Fig. 2-29. Large quantities of glass, pieces of window frame, and window shades were scattered throughout the interior of the house (see Figs. 2-30 and 2-31). Some plaster cracking was visible in several of the rooms.

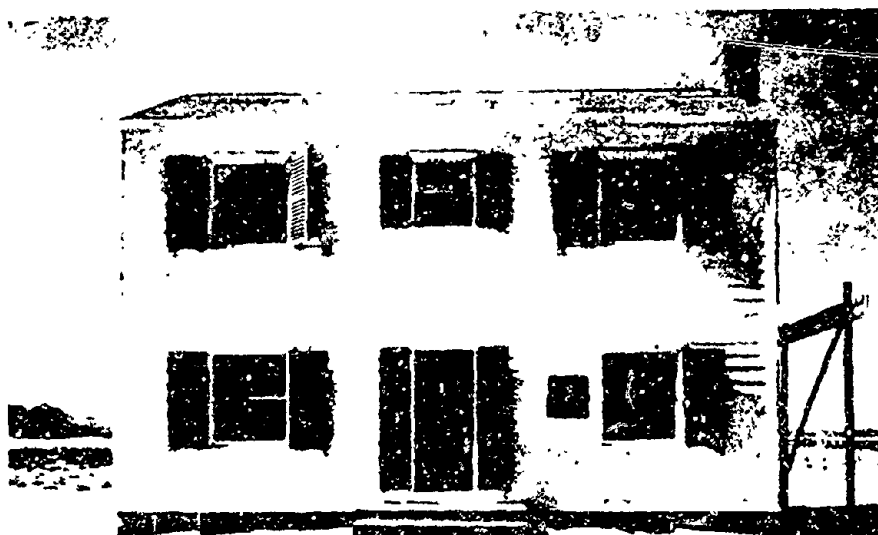
Fig. 2-32. Front Side of House I-6

After the first test the house previously discussed (I-5) was restored, as closely as possible, to a like-new condition. The two charges (5000-lb TNT cast hemispheres) were placed 865 ft from the house and detonated at approximately 20 msec intervals. The incident peak overpressure at the house was 1.2 psi. Figure 2-32 shows the front of the house after the test.

of the same area as in Fig. 2-27, shows that window damage was substantially greater after the second test than after the first. All windows forward of the centerline of the house were damaged.

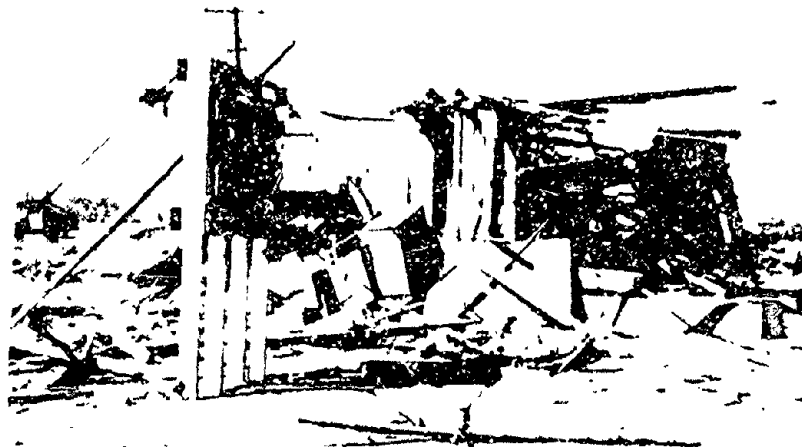
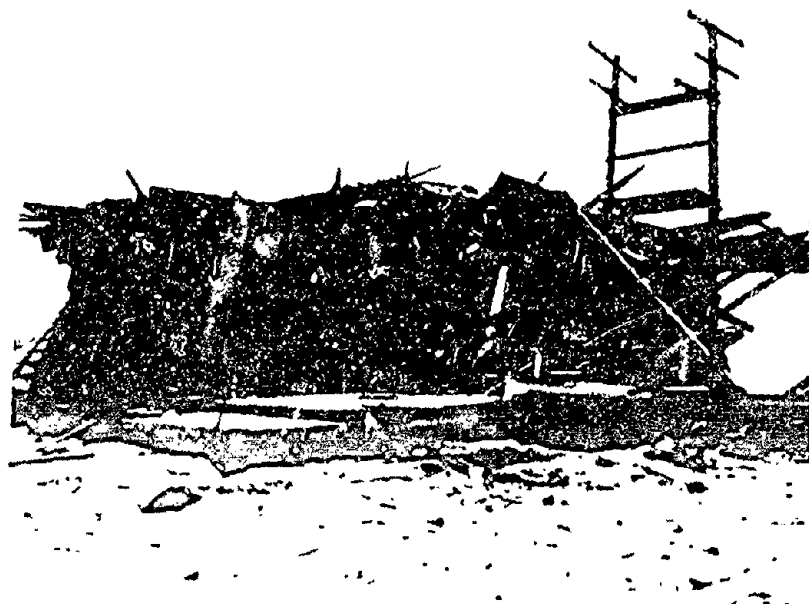
This house, located at 4700 ft from ground zero, experienced an incident peak overpressure of approximately 5.1 psi. The house was demolished beyond repair, with only the reinforced concrete bathroom shelter remaining intact (see Figs. 4-3 and 4-4). The roof was blown off; one section was found 100 ft to the rear of the house. All rafters were split and broken. The side walls at the gable ends were blown outward and landed approximately 75 ft to the rear of the house. A portion of the front wall was still standing, but leaning inward. The observation was made in the original reference that had it not been for the bathroom shelter, which served to give some measure of support to the house, the house would probably have been blown entirely from its slab foundation.

Fig. 1-3. Post-Test Photos, House III-1

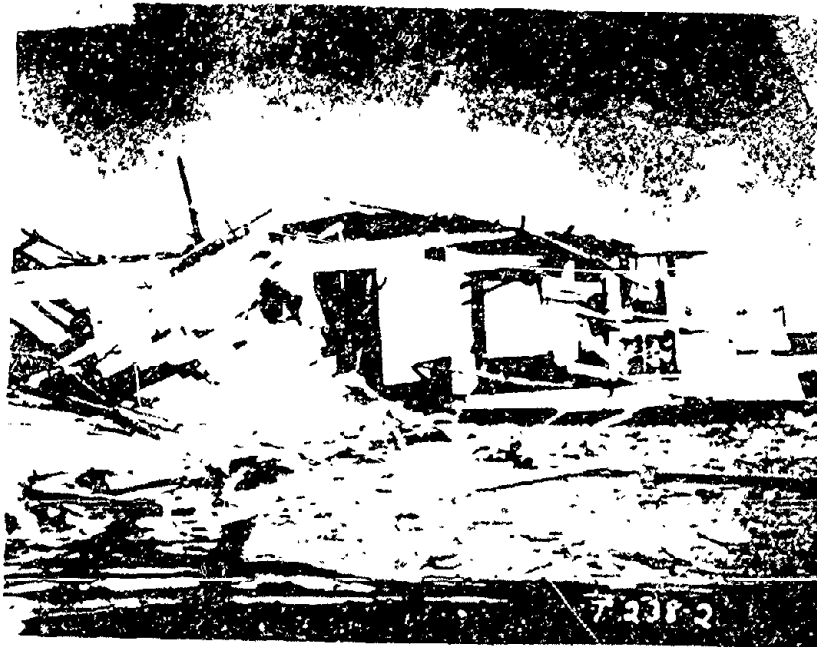
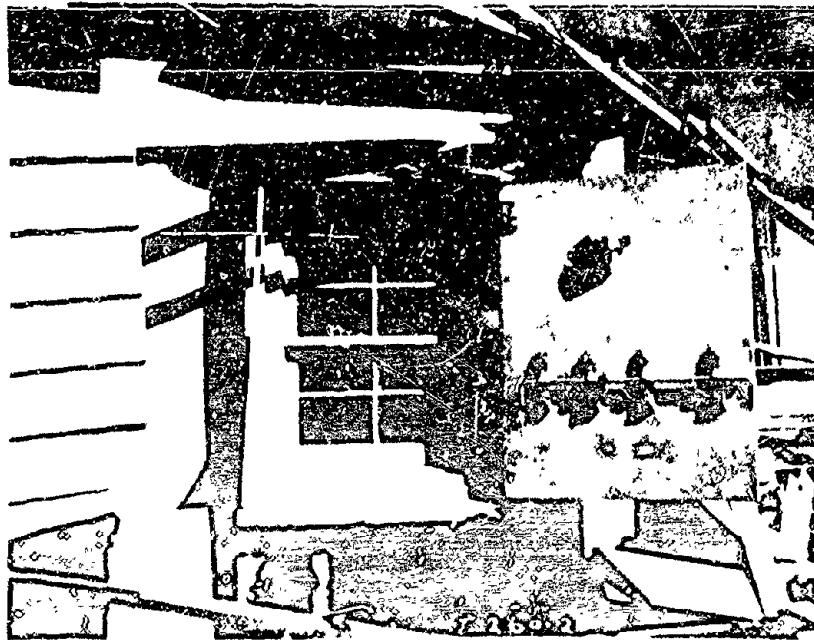
Fig. 4-4. Post-Test Photos, House III-1

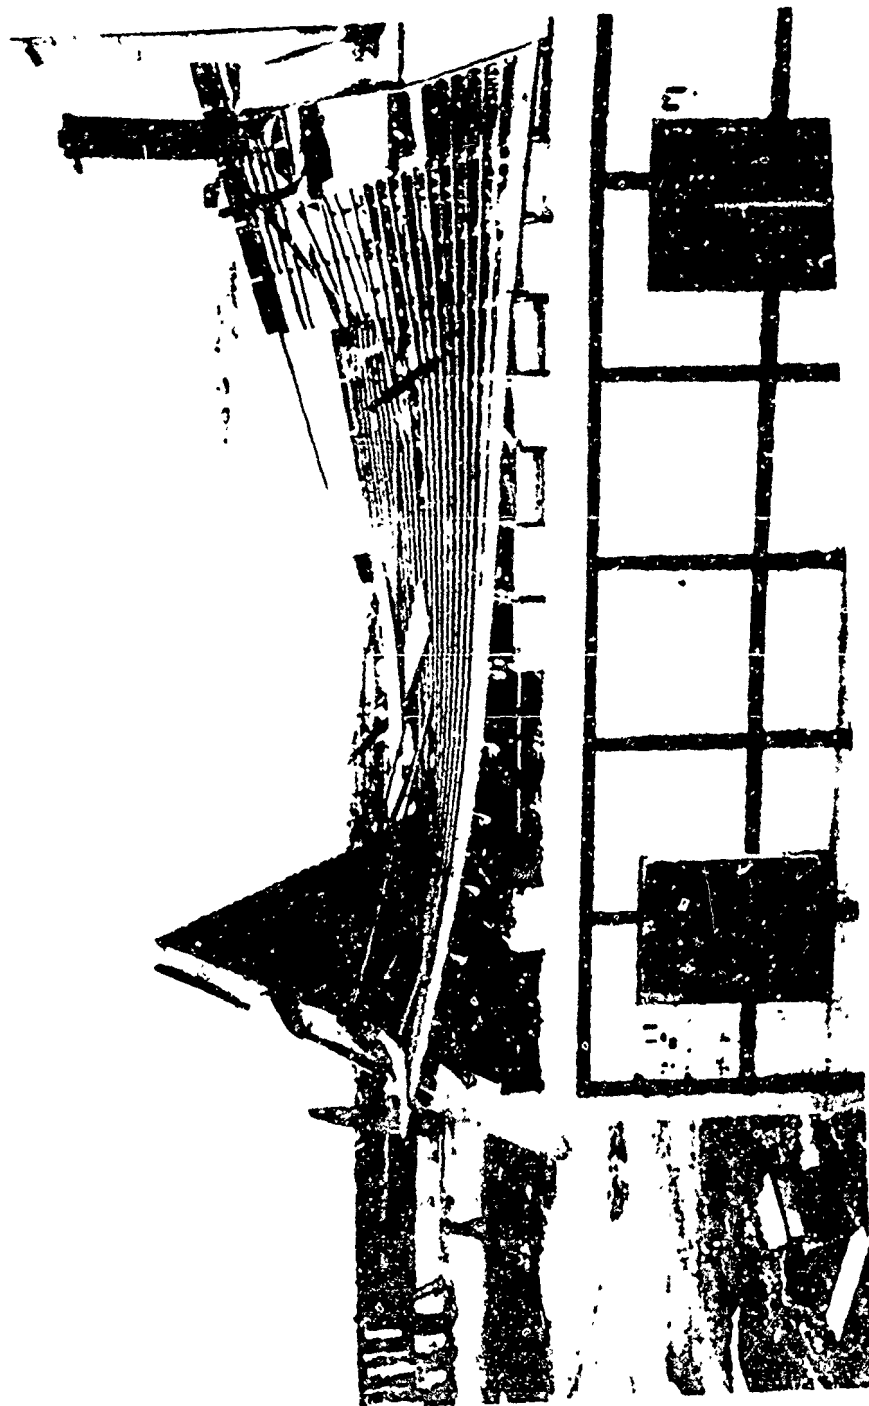
The central chimney broke off at the level of the attic floor and dropped in several sections on the ceiling over the stairwell. The left rear chimney was cracked through at the level of the roof, but, although it was slightly displaced, it did not fall. About 80 percent of the fill-in brickwork under the eaves was racked and displaced. The gable of the right wall was cracked through on a horizontal line about 3-1/2 ft down from the peak. Except for this, there was no visible damage to any of the brick walls. Figures 5-7, 5-8, and 5-9 are general views of house No. IV-1 in the post-test condition.

Fig. 5-7. Post-Test Photo, Right Side of House IV-1 (viewed from the rear)

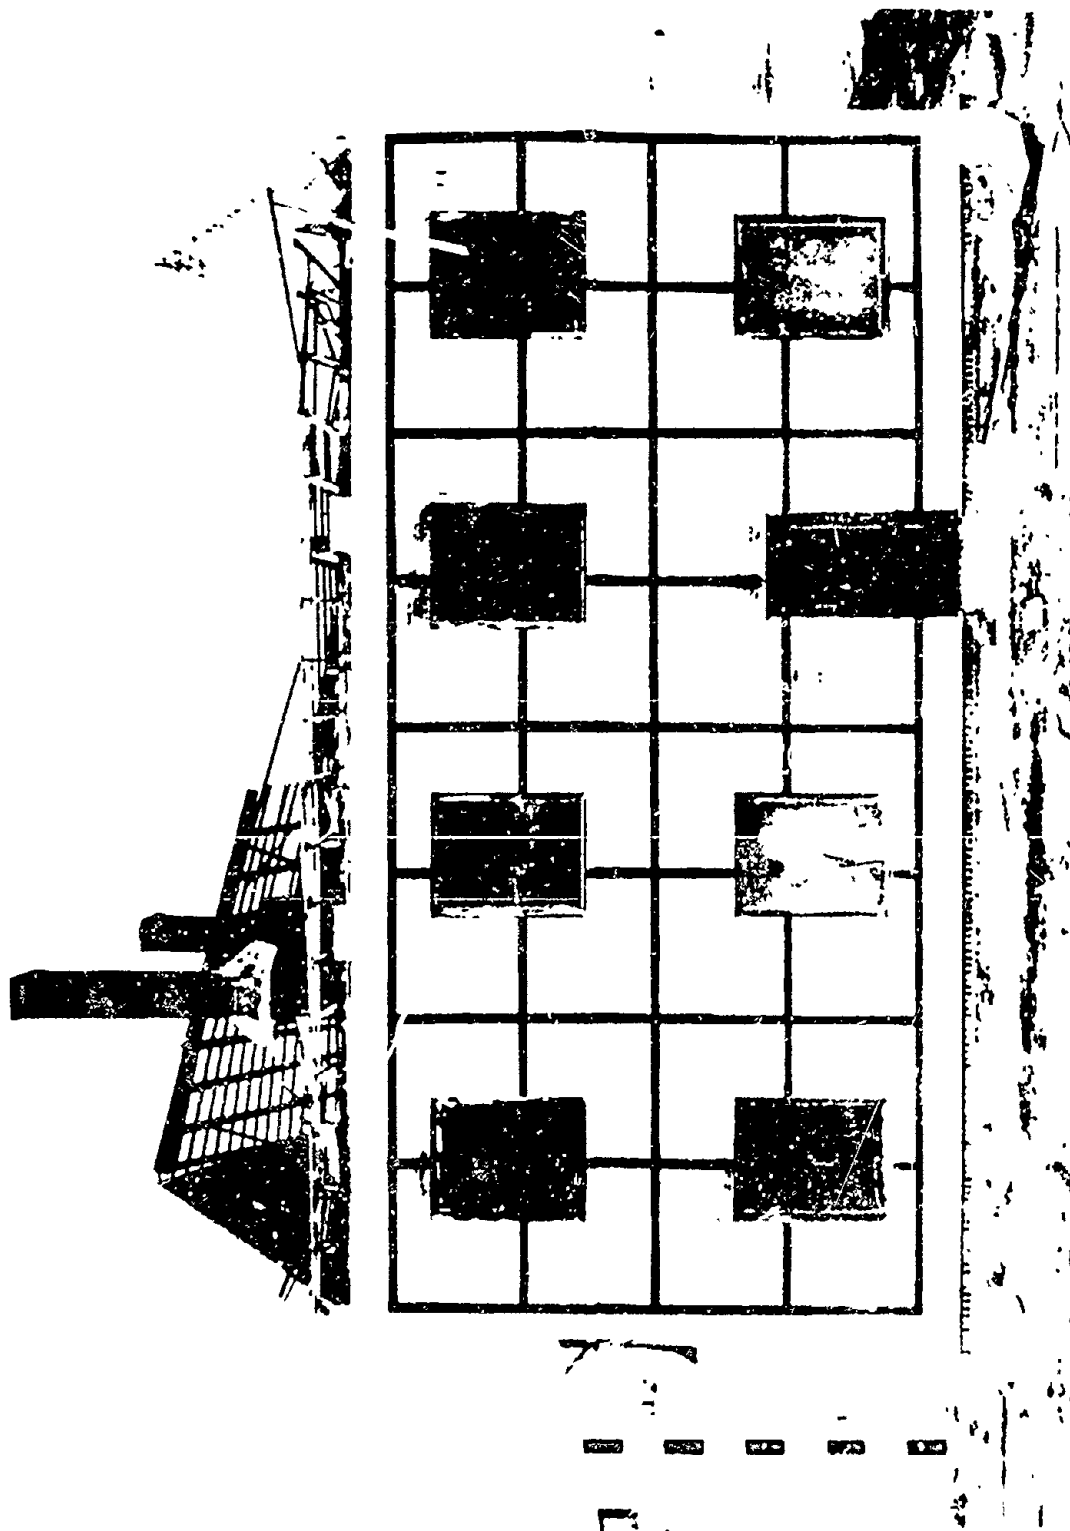
Fig. 5-8. Post-Test View, Rear of House IV-1

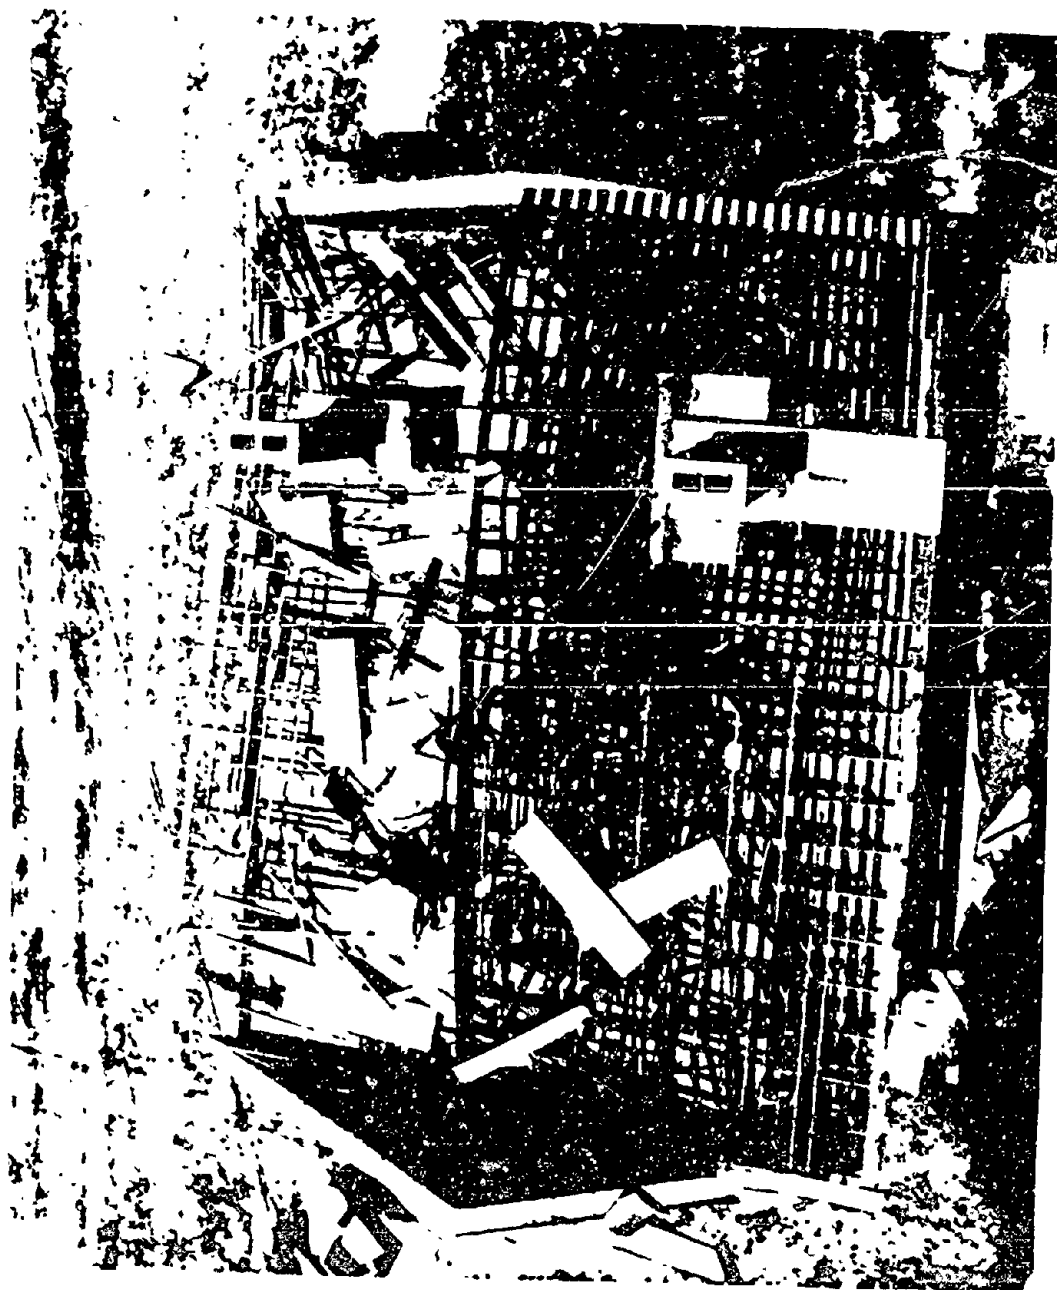
Fig. 5-9. Post-Test Aerial View, House IV-1

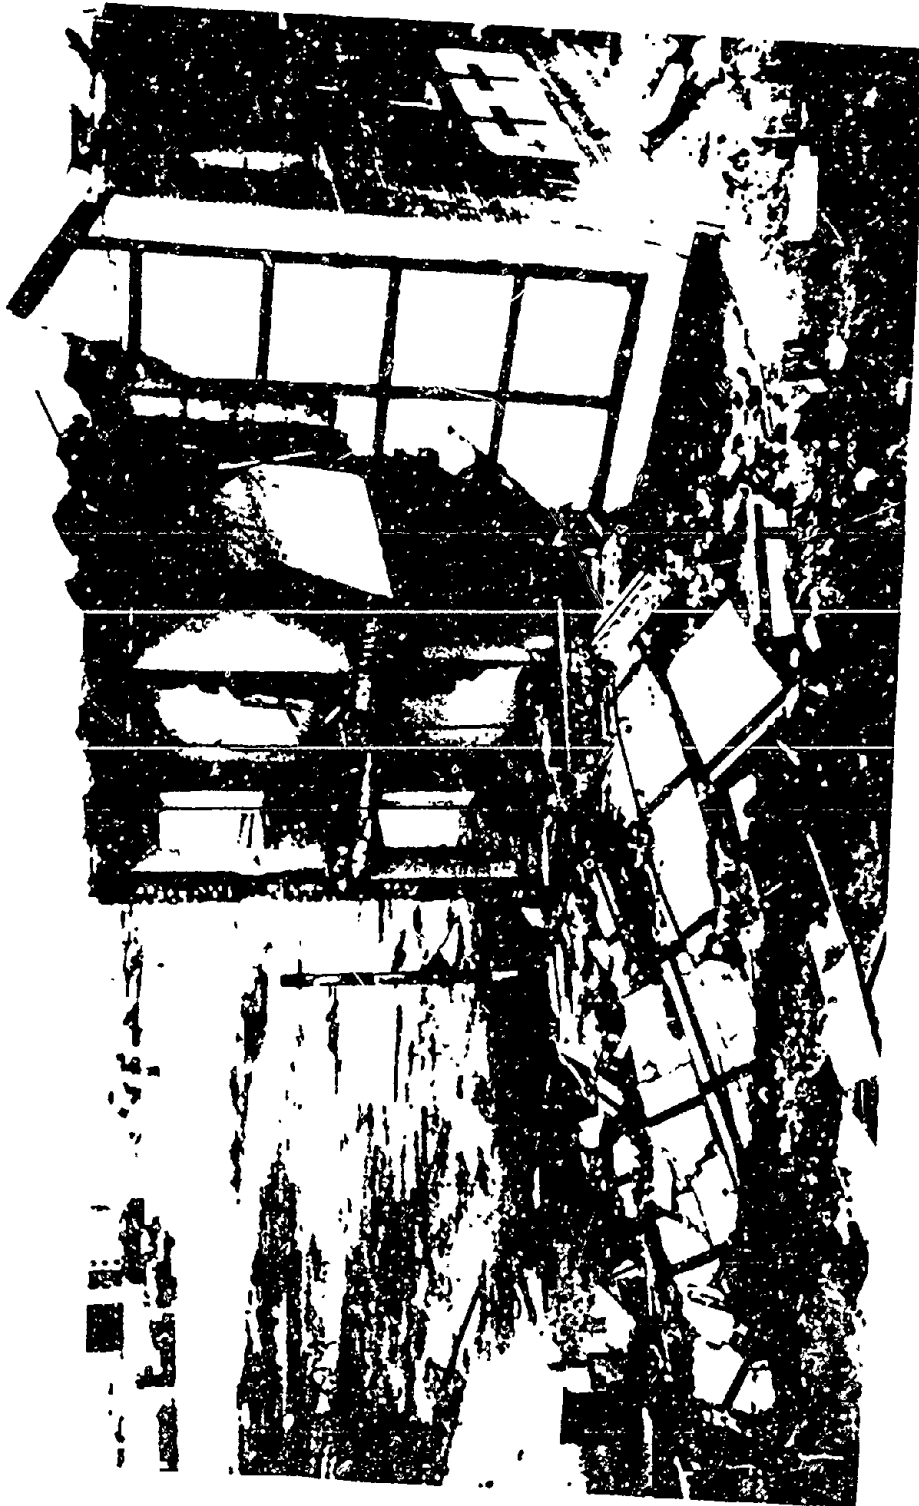
This house was located at 4245 ft from ground zero where the incident peak overpressure was 9 psi. Reference 7, from which this damage information was obtained, estimated the blast damage to be 40 percent.* Above the second story this structure was razed; the chimneys were toppled, and the roofing and roof rafters were carried away. Both brick gables fell vertically to positions beneath their original locations: the left wall was toppled as a unit to the side, and the forward 75 percent of the right wall was blown out to the side in two sections separated along the line of the first floor ceiling. (Here, and throughout this section, right and left are defined with the observer's back to ground zero.) With the exception of one pane of glass which remained in the window above the stair landing, all glass in the building was blown in. Doors were blown off or were broken off beyond the rear stile. Figures 5-11 through 5-14 are photographs showing general aspects of the blast-damaged building.

Fig. 5-12. Post-Test, Right Side of House IV-2

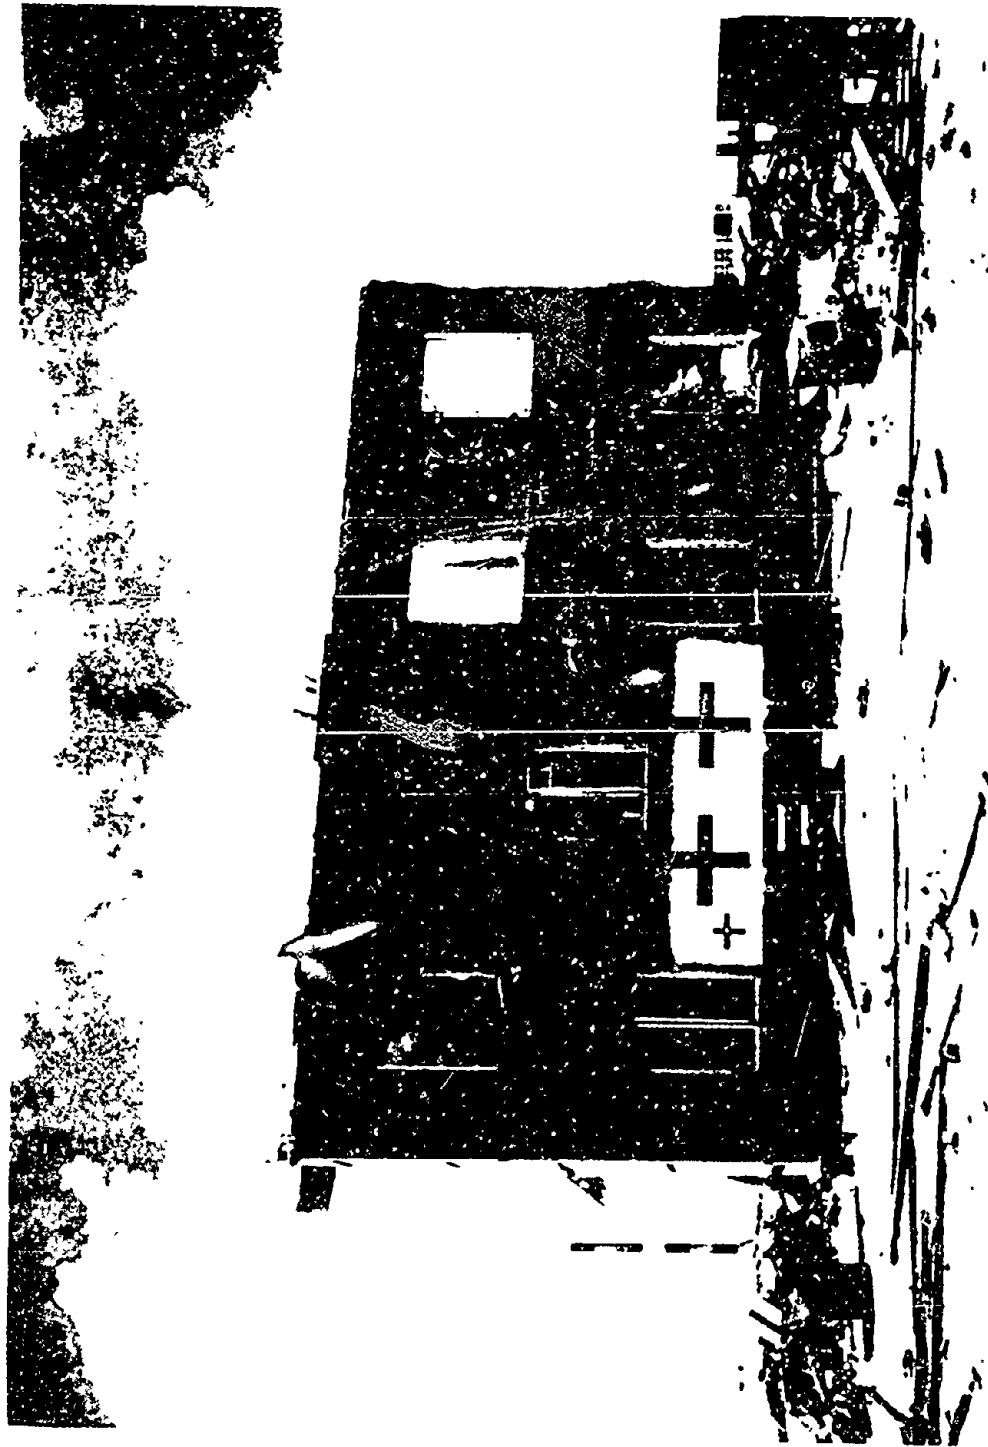
Fig. 5-13. Post-Test, Rear View of House IV-2

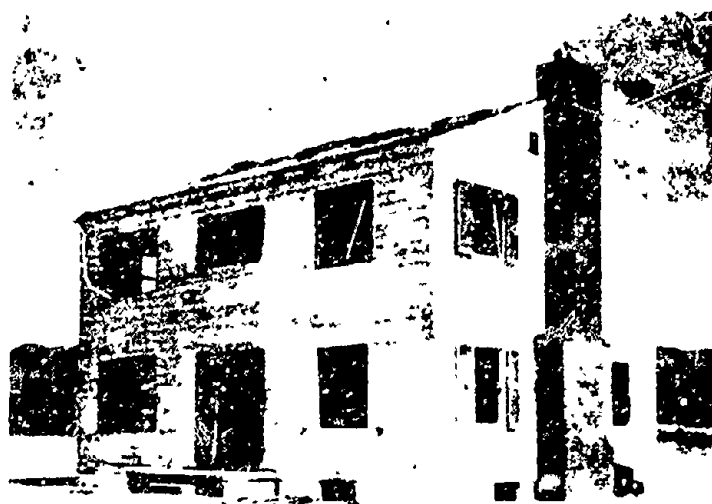
Fig. 6-1. House Damage Summary, House No. I-1

ITEM	DAMAGE PERCENT (each element)	CHANGE PERCENT (total value)
Floor and Ceiling Framing	12	2.0
Roof Framing and Roof Surface	35	2.5
Exterior and Interior Wall Framing	9	1.4
Interior Plaster	5	0.6
Exterior Sheathing and Siding	0	0
Doors	50	2.3
Windows	88	4.2
Foundation and Basement	0	0
Misc.: Stairs, Fireplace Paint, Trim	6	0.7
TOTAL		13.7

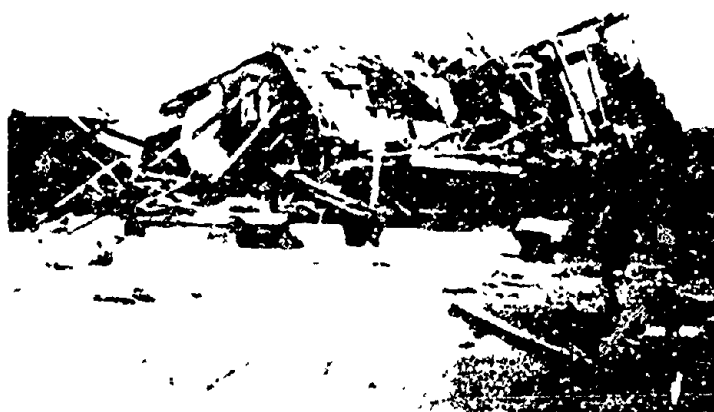
Fig. 6-2. House Damage Summary, House No. 1-2

ITEM	DAMAGE PERCENT (each element)	CHANGE PERCENT (total value)
Floor and Ceiling Framing	100	17.0
Roof Framing and Roof Surface	100	7.0
Exterior and Interior Wall Framing	100	16.0
Interior Plaster	100	11.0
Exterior Sheathing and Siding	100	8.6
Doors	100	4.6
Windows	100	4.8
Foundation and Basement	3	0.6
Misc.: Stairs, Fireplace, Paint, Trim	100	<u>12.0</u>
TOTAL		81.6

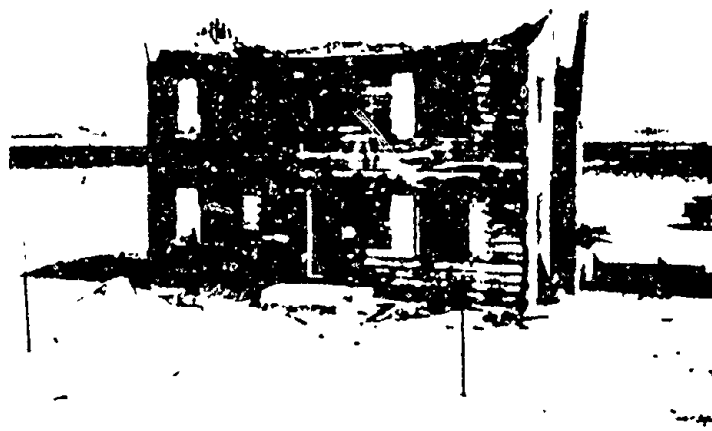
Fig. 6-3. House Damage Summary, House No. 1-3

ITEM	DAMAGE PERCENT (each element)	CHANGE PERCENT (total value)
Floor and Ceiling Framing	20	3.4
Roof Framing and Roof Surface	100	7.0
Exterior and Interior Wall Framing	8	1.3
Interior Plaster	30	3.3
Exterior Sheathing and Siding	25	2.2
Doors	100	4.6
Windows	100	4.8
Foundation and Basement	0	0
Misc.: Stairs, Fireplace Paint, Trim	75	<u>9.0</u>
TOTAL		35.6

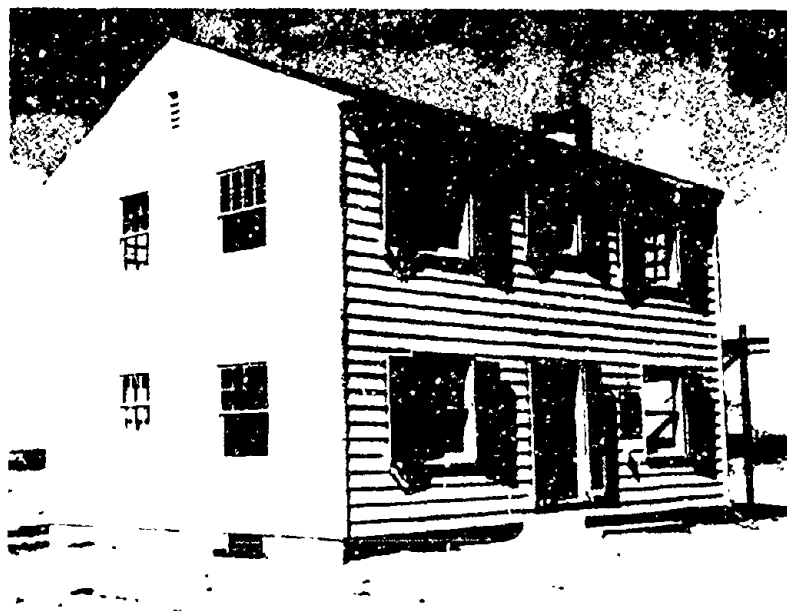
Fig. 6-5. House Damage Summary, House No. I-5

ITEM	DAMAGE PERCENT (each element)	CHANGE PERCENT (total value)
Floor and Ceiling Framing	0	0
Roof Framing and Roof Surface	1	0.1
Exterior and Interior Wall Framing	0	0
Interior Plaster	6	0.7
Exterior Sheathing and Siding	0	0
Doors	20	0.9
Windows	44	2.1
Foundation and Basement	0	0
Misc.: Stairs, Fireplace, Paint, Trim	12	1.4
TOTAL		5.2

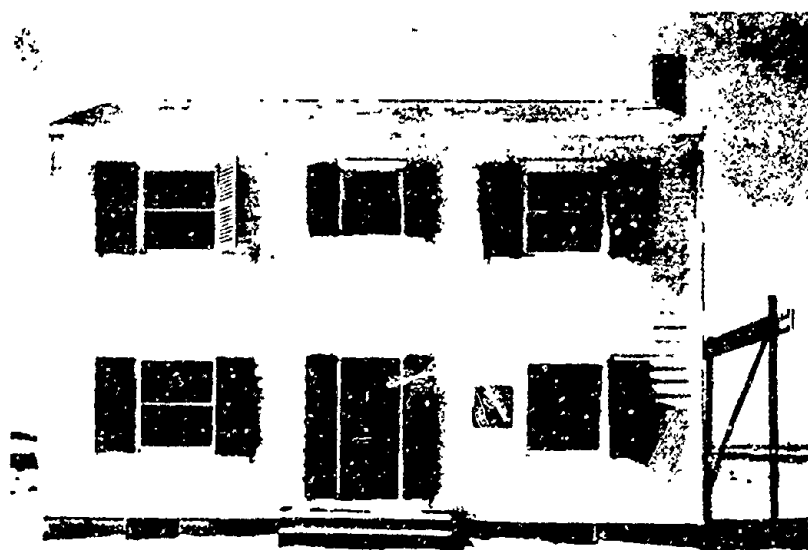
Fig. 6-6. House Damage Summary, House No. 1-6

ITEM	DAMAGE PERCENT (each element)	CHANGE PERCENT (total value)
Floor and Ceiling Framing	0	0
Roof Framing and roof Surface	3	0.2
Exterior and Interior Wall Framing	0	0
Interior Plaster	6	0.7
Exterior Sheathing and Siding	0	0
Doors	20	0.9
Windows	61	2.9
Foundation and Basement	0	0
Misc.: Stairs, Fireplace, Paint, Trim	15	<u>1.8</u>
TOTAL		6.5

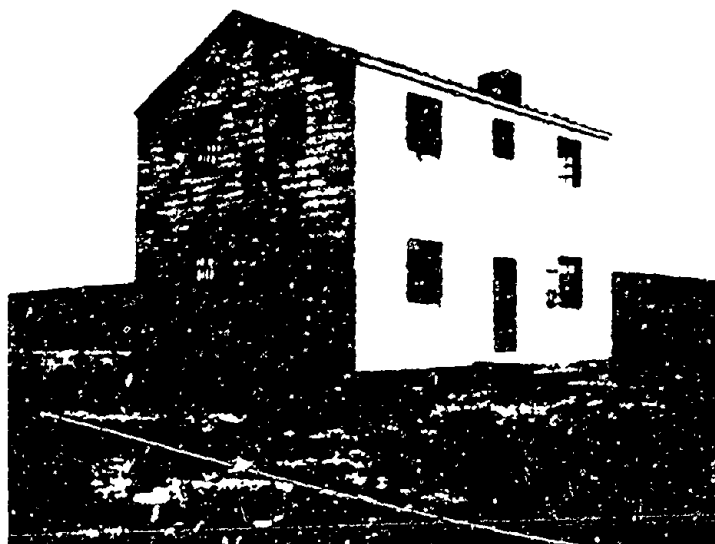
Fig. 6-7. House Damage Summary, House No. I-7

ITEM	DAMAGE PERCENT (each element)	CHANGE PERCENT (total value)
Floor and Ceiling Framing	0	0
Roof Framing and Roof Surface	14	1.0
Exterior and Interior Wall Framing	3	0.5
Interior Plaster	5	0.6
Exterior Sheathing and Siding	0	0
Doors	18	0.8
Windows	17	2.3
Foundation and Basement	0	0
Misc.: Stairs, Fireplace, Paint, Trim	3	<u>0.4</u>
TOTAL		5.6

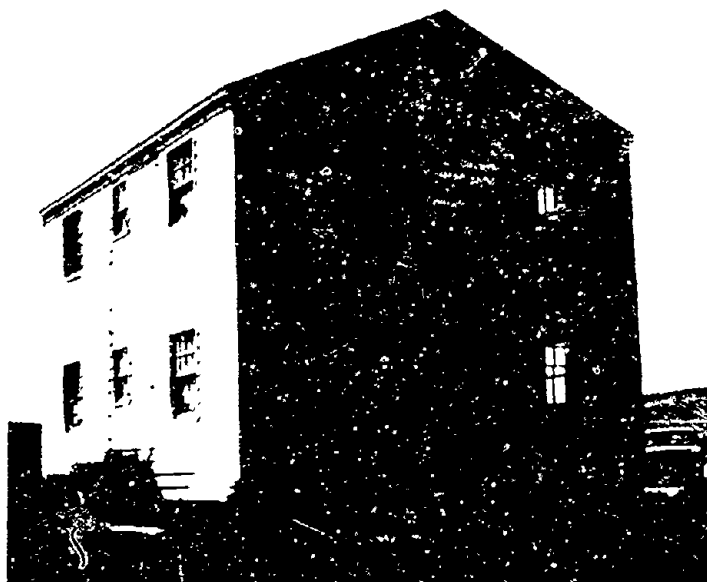
Fig. 6-8. House Damage Summary, House No. I-8

ITEM	DAMAGE PERCENT (each element)	CHANGE PERCENT (total value)
Floor and Ceiling Framing	0	0
Roof Framing and Roof Surface	27	1.9
Exterior and Interior Wall Framing	7	1.1
Interior Plaster	25	2.8
Exterior Sheathing and Siding	2	0.2
Doors	17	0.8
Windows	55	2.6
Foundation and Basement	0	0
Misc.: Stairs, Fireplace, Paint, Trim	12	<u>1.4</u>
TOTAL		10.8

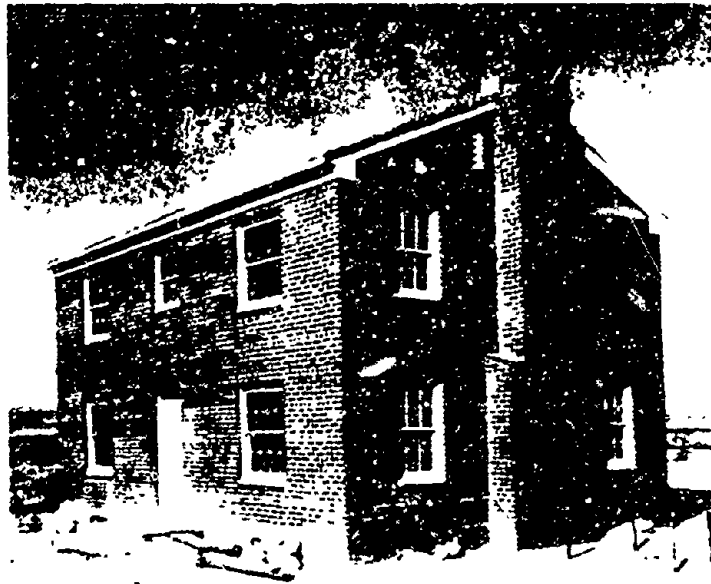
Fig. 6-12. House Damage Summary, House No. II-1

This house was located 10,500 ft from ground zero where the incident peak overpressure was 1.9 psi. There was no apparent damage to the masonry of this house (see Fig. 3-4). However, there was considerable damage to the roof and second floor ceiling framing (see Fig. 3-5). The connections of the rear rafters to the ridge failed, and the rafters dropped 4 to 6 in. below the ridge. The ridge split in the center portion, and some of the 2- by 4-in. collar beams broke in half. The ceiling joists over the rear bedroom split at midspan, and the lath and plaster ceiling was blown down into the room. The second floor framing suffered little or no damage. A few first floor joists were fractured (see Fig. 3-6). The glass in the front and side windows was blown in, and the glass in the rear windows suffered some damage. The exterior doors were blown in and demolished, and several interior bedroom and closet doors were blown off their hinges. The stair rail was broken, and the interior plastered wall and ceiling finish were badly damaged.

ITEM	DAMAGE PERCENT (each element)	CHANGE PERCENT (total value)
Floor and Ceiling Framing	12	2.0
Roof Framing and Roof Surface	30	2.1
Exterior and Interior Wall Framing	0	0
Interior Plaster	15	1.7
Exterior Sheathing and Siding	0	0
Doors	17	0.8
Windows	80	3.8
Foundation and Basement	0	0
Misc.: Stairs, Fireplace, Paint, Trim	1	0.5
TOTAL		10.9

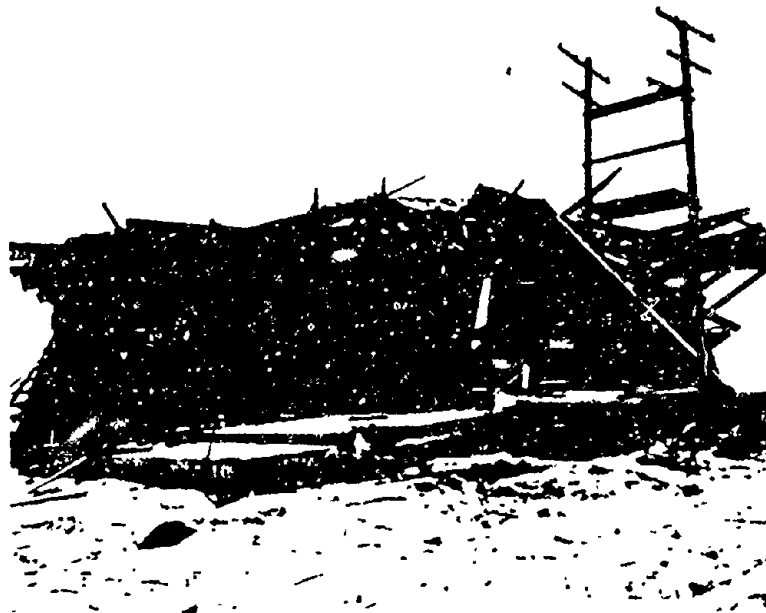
Fig. 6-17. House Damage Summary, House No. III-2

ITEM	DAMAGE PERCENT (each element)	CHANGE PERCENT (total value)
Floor and Ceiling Framing	100	17.0
Roof Framing and Roof Surface	100	7.0
Exterior and Interior Wall Framing	100	16.0
Interior Plaster	100	11.0
Exterior Sheathing and Siding	100	8.6
Doors	100	4.6
Windows	100	4.8
Foundation and Basement	3	0.6
Misc.: Stairs, Fireplace, Paint, Trim	100	<u>12.0</u>
TOTAL		81.6

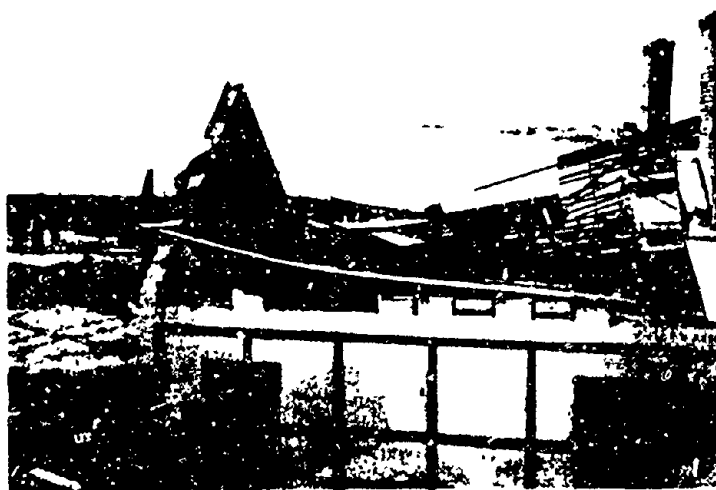
FIG. 6-18. House Damage Summary, House No. IV-1

This house was located 7020 ft from ground zero where the incident peak overpressure was 3.6 psi. Reference 7, from which the damage information was obtained, estimated the blast damage to be 10 percent.

ITEM	DAMAGE PERCENT (each element)	CHANGE PERCENT (total value)
Floor and Ceiling Framing	10	1.7
Roof Framing and Roof Surface	100	7.0
Exterior and Interior Wall Framing	20	3.2
Interior Plaster	20	2.2
Exterior Sheathing and Siding	10	0.9
Doors	25	1.2
Windows	80	3.8
Foundation and Basement	0	0
Misc.: Stairs, Fireplace, Paint, Trim	25	3.0
TOTAL		23.0

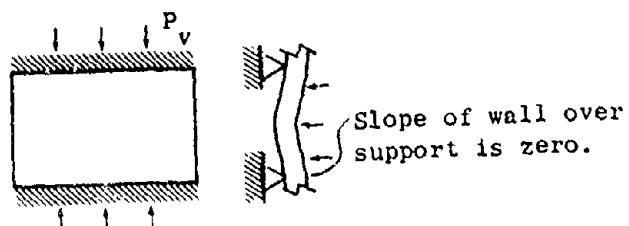
Solid Wall
Fixed (moment resisting) Support
(preloaded)

0.5 to 2.0 psi
(estimated)

NON-REINFORCED BRICK WALLS (8' x 12' x 8")

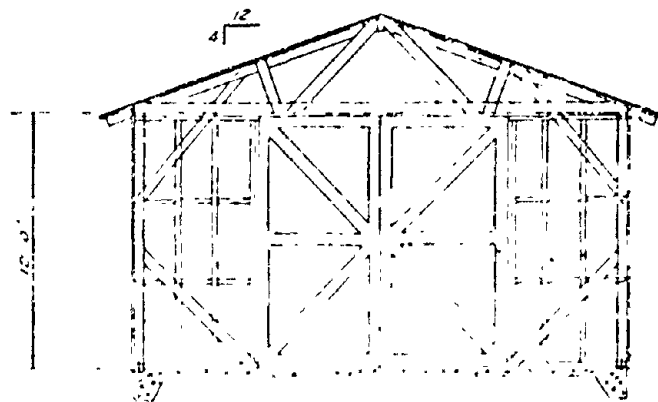
The construction details are shown below. The framing consisted of 2- x 4-in. studs, and 2- x 4-in. trussed rafters with a 2- x 6-in. bottom chord 2 ft o.c. and with a 2- x 4-in. knee bracing 8 ft o.c. The siding was 3/8-in. exterior plywood and the roofing was of corrugated aluminum sheet metal secured to 1- x 4-in. nailing strips. The size of the building was estimated to be 25 x 60 ft.

Warehouses, Structural Damage

Using the same damage estimate procedures that were used for the air operations building the following summary of blast damage was derived.

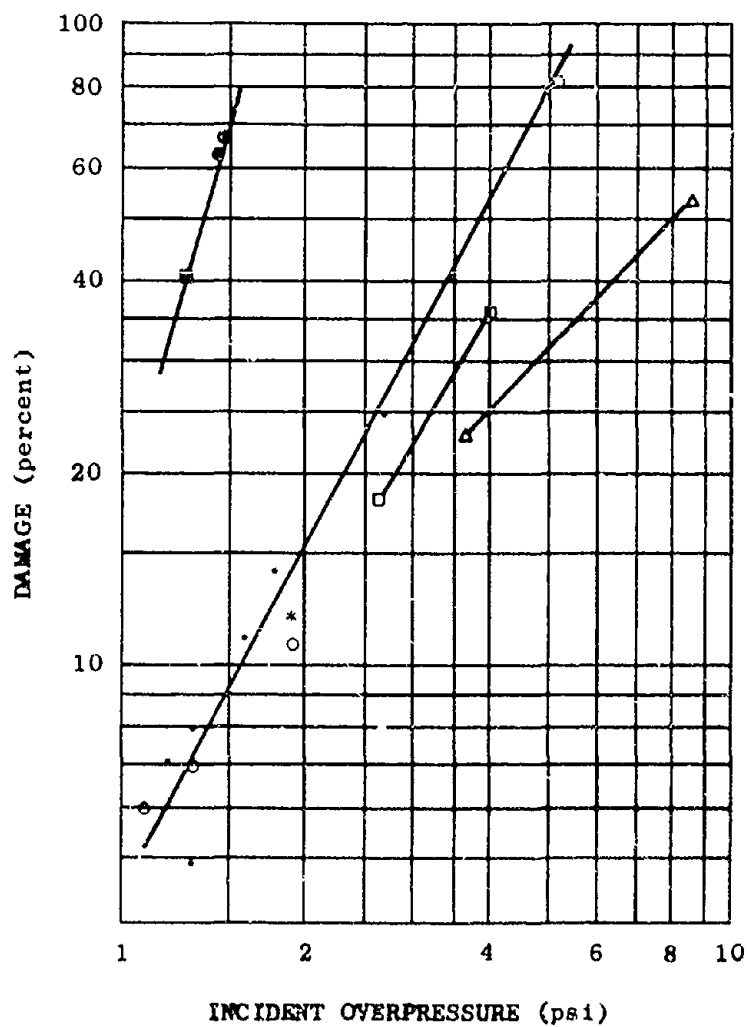
Fig. B-1. Percent Damage vs Incident Overpressure (psi)

noted that these structures are considerably weaker than the Type I house, that is, they sustained more damage at the same overpressure.
